Asbestos Survey

Kenyon Consulting #4024

4024 Rosemary Cir, West Valley, UT

Asbestos Inspection

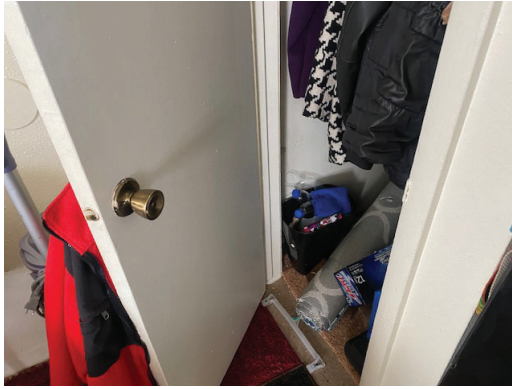
DW

The joint compound contains an estimated <1% asbestos by point count. A point count analysis would be required to confirm the <1% asbestos content and unless this is done the material, all drywall systems in the structure, will need to be treated as asbestos containing and should only be disturbed/removed by licensed asbestos professionals. A point count is recommended.

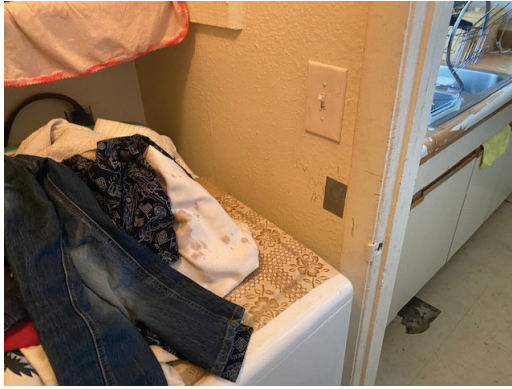
DW

The joint compound contains an estimated <1% asbestos by point count. A point count analysis would be required to confirm the <1% asbestos content and unless this is done the material, all drywall systems in the structure, will need to be treated as asbestos containing and should only be disturbed/removed by licensed asbestos professionals. A point count is recommended.
