Asbestos Survey

Kenyon Consulting #4024

4024 Rosemary Cir, West Valley, UT

Asbestos Inspection

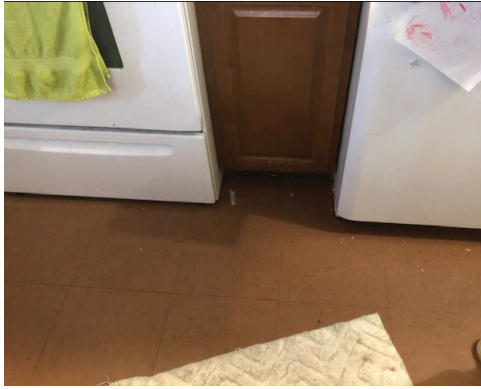
Sample ID	Material	ACBM Location	Analysis	Sample Results	RACM	Point Count	Quantity
1	Red Vinyl Tile	Kitchen	PLM	None Detected	NO		150 sf
2	Beige Vinyl Tile	1/2 Bathroom	PLM	None Detected	NO		50 sf
3	White Drywall w/ Texture	Laundry Ceiling	PLM	None Detected	NO		980 sf
4	White Drywall w/ Texture	1/2 Bathroom ceiling	PLM	None Detected	NO		980 sf
5	White Drywall w/ Texture	Kitchen Ceiling	PLM	None Detected	NO		980 sf
6	White Base Mastic	Laundry Wall D	PLM	None Detected	NO		70 lf
7	White Drywall System	Mechanical Room Wall A	PLM	Contains Asbestos 0.25% Chrysotile asbestos in joint compound by point count	No	0.25% asbestos	1000 sf
8	White Drywall System	Dining Room Wall C	PLM	Contains Asbestos 0.25% Chrysotile asbestos in joint compound by point count	No	0.25% asbestos	1000 sf
9	White Drywall System	2nd Bedroom Wall C	PLM	None Detected	NO		1000 sf
10	White HVAC Tape	Ductwork in mechanical room	PLM	Contains Asbestos 80% Chrysotile asbestos	YES		4 sf

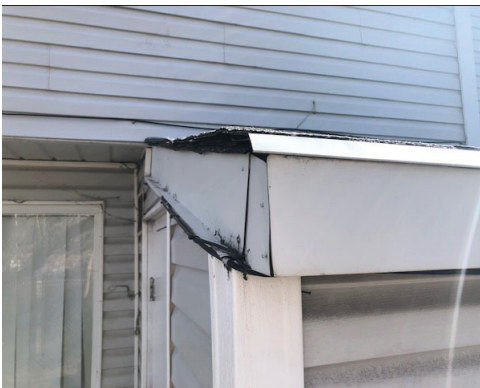
11	Black Roof System	Roof	PLM	None Detected	NO		1300 sf
